Implant Failure

Implant Failure: STRATOS® system for Pectus Repair.

Running Title: Failure of Pectus Repair Prosthesis

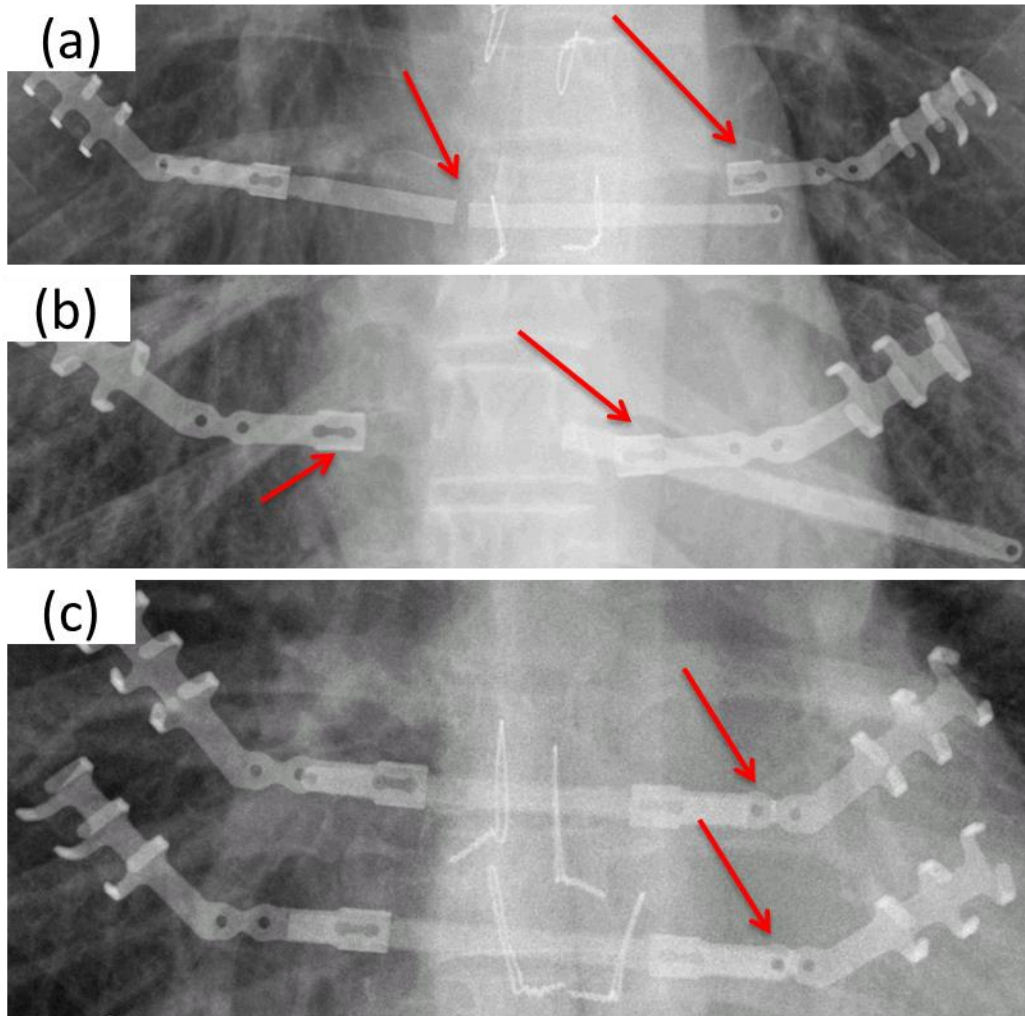
Failed STRATOS implant also brings the danger of loose and migrating long pieces of metal with sharp ends in the cardiothoracic region (Fig. 2a and b) with the vital blood carrying vessels and organs like heart and lung. A recent study reported migration of a pectus bar through the tricuspid valve into the right atrium of the heart damaging the right coronary artery and posterior leaflet of the tricuspid valve on the way(10).

Figure 2. Single or multiple failures observed in-vivo for single or double STRATOS implants placed for Pectus correction in the span of 14th December 2011 to 18th July 2013 at UMCG. (a) and (b) also showing loose implant pieces freely floating in the cardiothoracic region.

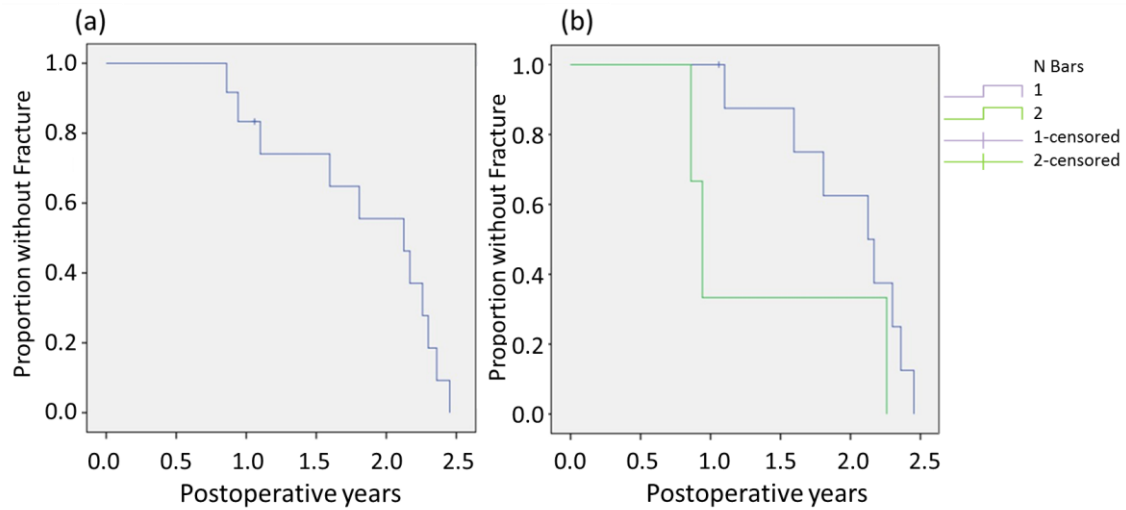
Kaplan Meier analysis shows that all Stratos implants failed from 4 months to 2½ years postoperatively (Fig 3). The graph shows a fairly steady rate of fracture up to 2 years postoperatively, whence about half of the patients have experience a fracture. In the half year thereafter, the remaining half of the patients experienced a fracture. There is no demonstrable difference between usage of two instead of 1 bar. The series is too small to demonstrate any difference between pre- or post-sternal implantation

Although estimation of the fatigue life of the implant is difficult, the first few fractures took place at about 10 months (Fig. 3) thus the crack initiation and fracture took about 8.5 million cycles, assuming an average respiration rate of 20 breaths per minute. STRATOS manufacturers provide 6 advantages in their information brochure for the use of pure titanium over stainless steel but fatigue resistance is not part of it. Comparing 8.5 million cycles to the standard fatigue life curve for pure, cold rolled, grade 3 titanium(8) shows that the implants are enduring more than 300 MPa of combined load.

Figure 3. Kaplan-Meier plots showing the cumulative survival of the STRATOS implants in vivo (a) when all the patients were taken together and (b) when the patients carrying single or double implants were separately analysed.

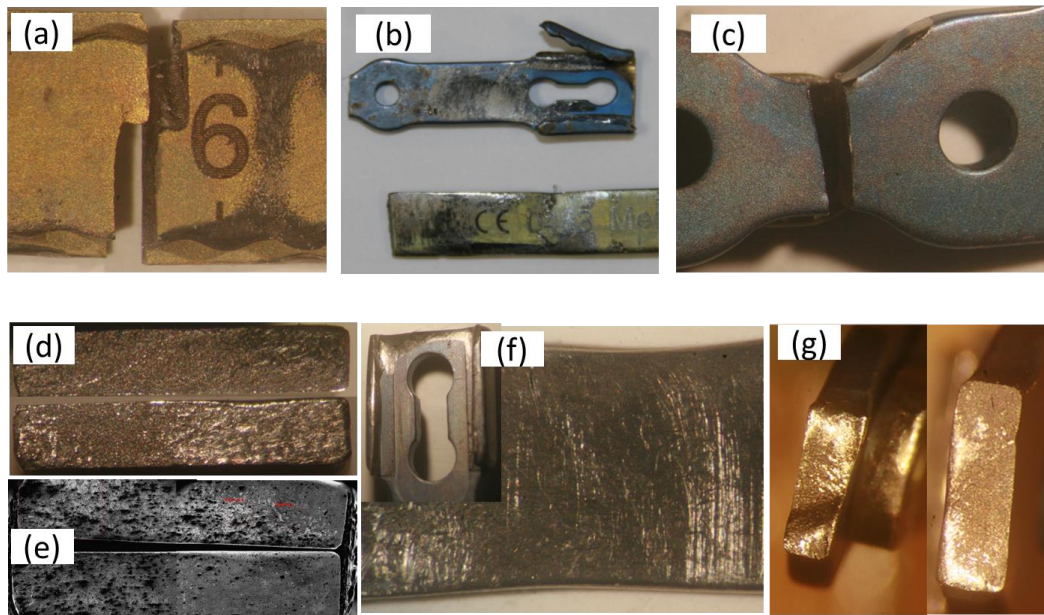
The 15 implants had 30 joints where the connecting bars were held in place by 30 crimp connectors. 7 out of the 30 joints (23%) showed Lcc and close analysis of these connectors showed severe rubbing of the connecting bar against the crimp connector (Fig. 4b) with clear metallic mass loss and sometimes also fracture of the crimp connector.

Of 15 connecting bars 7 were fractured, Fcb (47%) (Fig. 4a) and 10 of 30 rib clips (33%) were fractured at the spot of reduced cross-section, Frc (Fig. 4c). None of the fractures showed any signs of plastic deformation. High amounts of Titanium were found in the blackened tissue around the failure points (Table 1), further analysis showed that this Titanium is present in the form of debris aggregated at localized spots in the tissue (Fig 6).

Our findings indicate to fatigue as the mechanism for crack initiation and fracture of the connecting bars (F_{CB}) and rib clip (F_{RC}) by growth of the crack at each cycle of loading. Fatigue requires application of cyclic loading, in this case bending caused by breathing, which causes failure without any plastic deformation. Thus fatigue is, qua mechanism, different from failure under continuous loading (overload). Under the overload situation the material would first deform plastically and then fail, this can be clearly distinguished on examination of the fracture. Fatigue as a mechanism means that the implant design brings the material, at certain locations of the implant, under cyclic stresses which are larger than the material's fatigue limit. The STRATOS implants seemed to have come under heavy combined loading during the activity of breathing (Fig. 5). Immediately after implantation the rib clips held the implants tightly in place but during each breathing cycle the implant material would have experienced cycles of tensile and compressive stresses in combination with bending and torsional loads (Fig. 5). Estimation of the exact amounts of these stresses would remain impossible but it is clear that the normal loads (tension and compression) could cause the rubbing and sliding at the crimp connector - connecting bar interface, whereas the bending and

Figure 4. Three different types of failures observed (a) Clean fracture of the connecting bars, designated as F_{CB} , (b) Loosening and opening sometimes accompanied by fracture of the crimp connector leading to excessive rubbing between the connecting bar and the crimp connector, designated as L_{CC} , (c) Clean fracture observed on the lateral bar at the point of reduced cross-section and stress concentration, designated as F_{RC} , (d) optical and (e) SEM micrographs taken at 95x of F_{CB} from patient 1 showing the grainy and smooth area of the fractured surface, (f) Gross wear of the crimp connector and the connecting bar due to loosening L_{CC} in patient 1 and (g) the two sides of the clean fracture in the lateral bar for patient 8

For all future use the Ti implant design should be changed so that the maximum stress active on the implant *in vivo* should be much lower than 300 MPa.

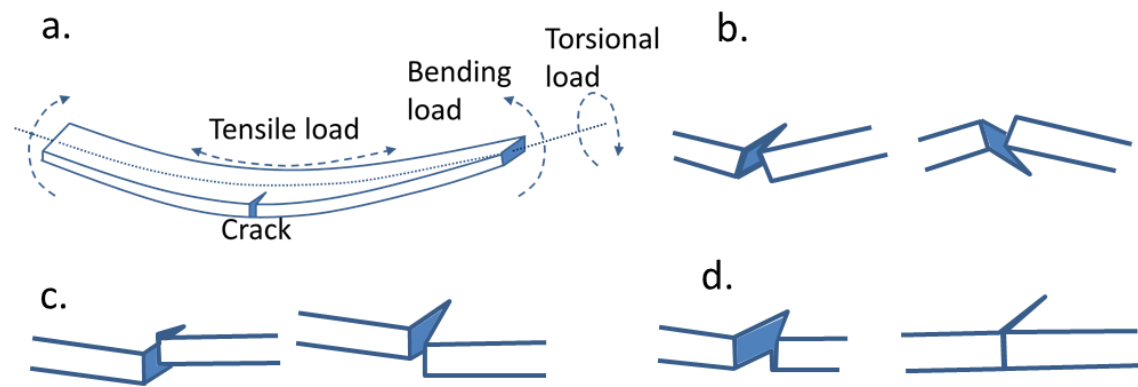
Figure 5.

torsional moment could cause opening of the crimp connector resulting in loosening. The same tensile, bending and torsional loading was able to initiate a fatigue crack in the connecting bars (F_{CB}) or rib clip (F_{RC}) which grew rapidly to give rise to implant failure, although we were not able to see this process of crack initiation and growth during the follow-up X-rays. The fact that all the fractures were clean (Fig. 4 a, c, d, e) i.e. without any sign of plastic deformation in a ductile material such as Titanium, and the presence of Titanium ions (Table 1) and debris (Fig. 6) in the surrounding tissue indicates strongly to fatigue failure mechanism. Titanium ions and debris around both the loosening and failures sites of the implant indicates large amount of friction and wear during either the process of loosening (Fig. 4b), crack growth (Fig. 5) or, when the two loosened or failed end of the implant were lying next to each other before retrieval (Fig. 6b).

Combined loading on the implant during each breathing cycle causing the fatigue crack to grow in the connecting and lateral bars of the Stratos implant.

Exaggerated crack deformation under repeated bending (a), torsional (b) and tensile (c) loads.

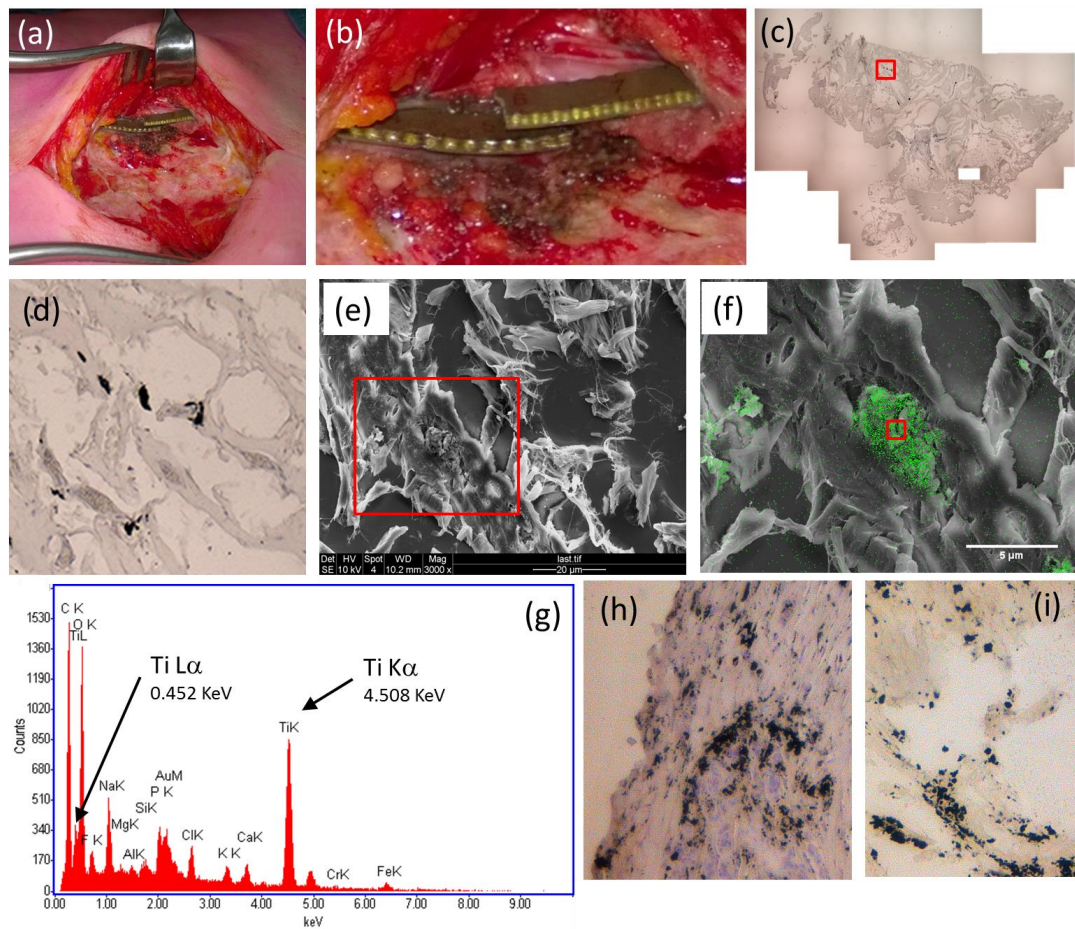
The clinical consequences of the presence of Ti and Ti debris along with freely floating implant pieces in the thoracic area could possibly impact negatively on the patient's wellbeing leading to metallosis (9) which is an ill-defined condition described after orthopaedic surgical implants elsewhere in the body.

Figure 6. Presence of Ti wear debris at the failure site. (a) Preoperative failure site for patient no. 10 from Table 1, (b) Close-up of the failure site from which a biopsy was taken and fixated, (c) Haematoxylin stained section of the biopsy tissue, individual frames obtained at 10 X, (d) Optical micrograph taken at 10X from the red square shown in c (e) Scanning electron micrograph (SEM) taken from the red square shown in c clearly shows presence of individual and aggregated debris, (f) Overlay of Ti K α peak intensity map on the SE micrograph from the red rectangle shown in e, (g) High Ti peaks (K α and L α) visible on the Energy Dispersive X-ray Spectroscopy (EDX) spectrum taken at the red spot on f, (h) and (i) optical micrographs taken at 10x of respectively stained and unstained sections from biopsies taken for other failed implants, black spots showing presence of wear debris.

In conclusion, despite approval by responsible organizations in Europe and USA we show that the STRATOS implant and material used is not suitable for pectus repair as it shows fatigue fractures in virtually all cases and is not well designed for easy explanation. Furthermore, we advise close follow-up of patients with implanted STRATOS material, including X-rays.
